Spring Valley Lake Fall 2014 Baseline Data Collection

Prepared for
Spring Valley Lake Association

AquaTechnex,
LLC

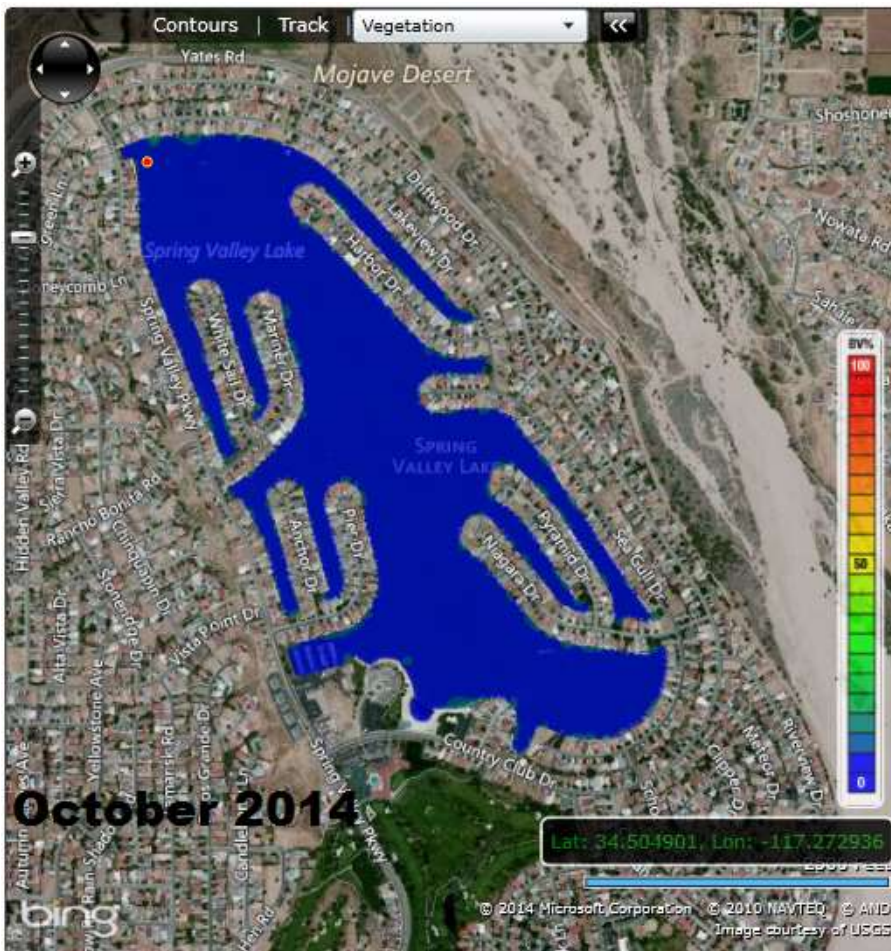
Vegetation

At the time the hydro-acoustic mapping was performed, there was light coverage throughout Spring Valley Lake. Nearly all plant growth is observed near the shoreline, with the densest areas located on the North and South Shores. The density of vegetation in the fingers varied.

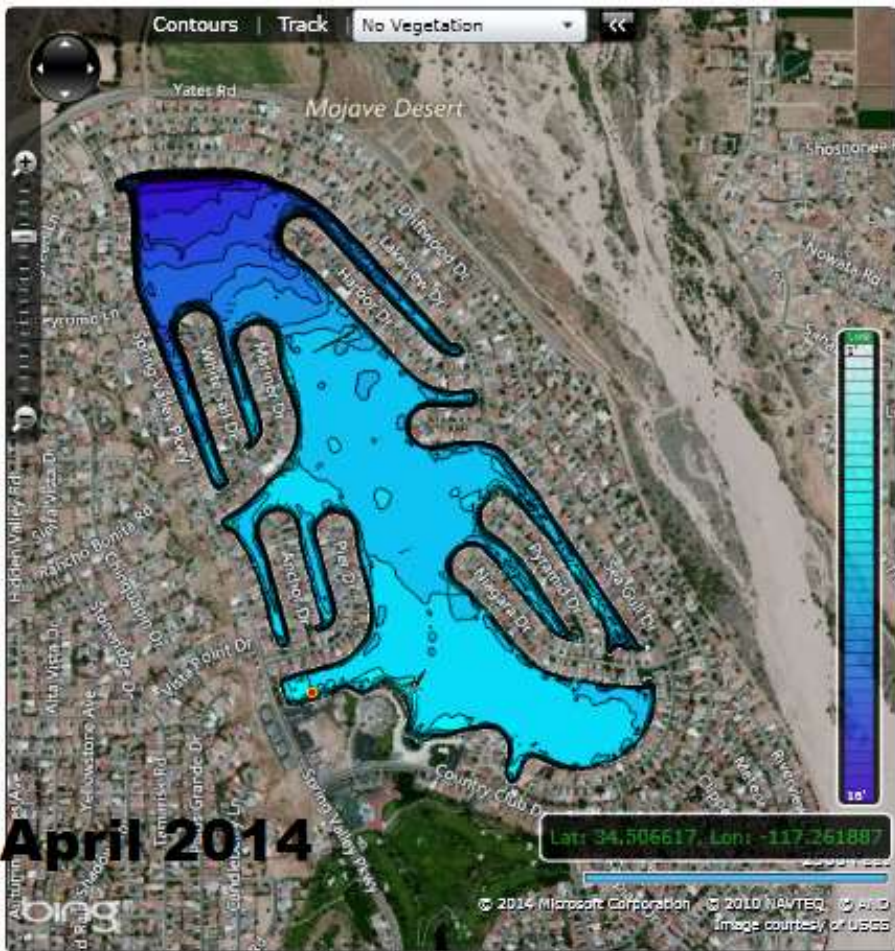
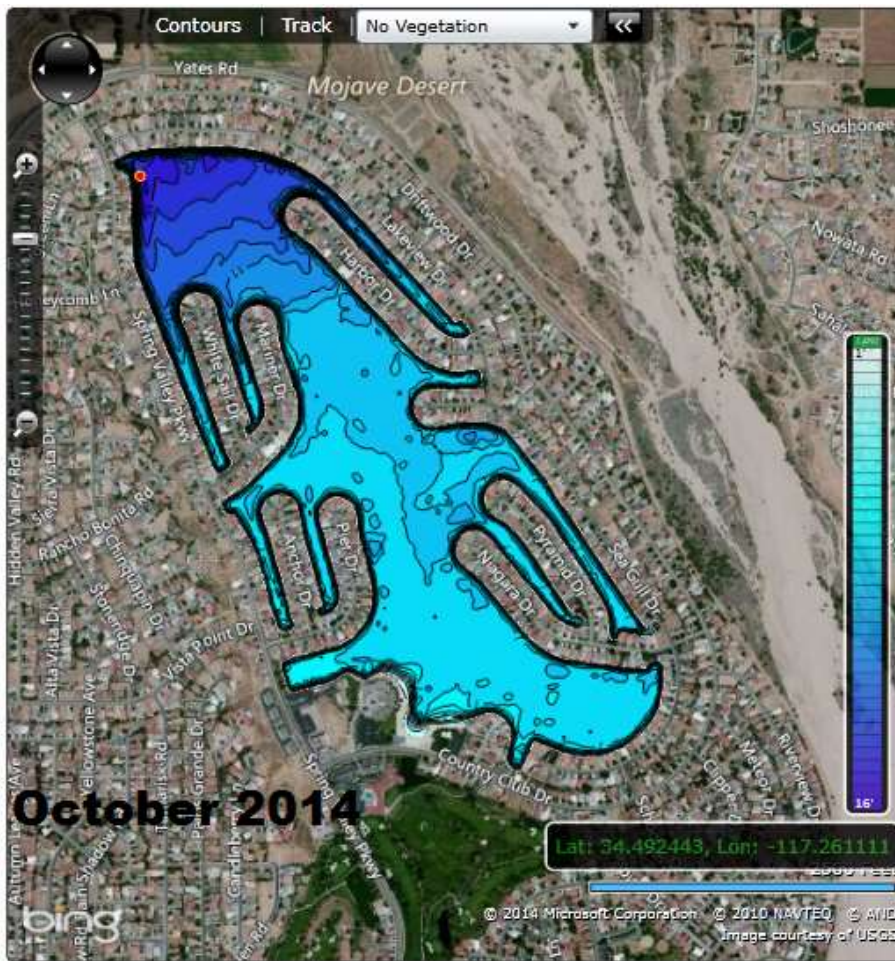
Contour

Between the two mapping events, we can see that sedimentation has occurred. In the middle section, you can see the deposition of sediment spreading from the east towards the center. In the north basin, slight changes have also been observed.

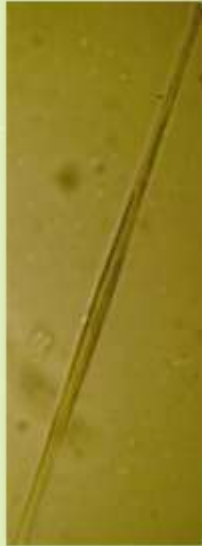
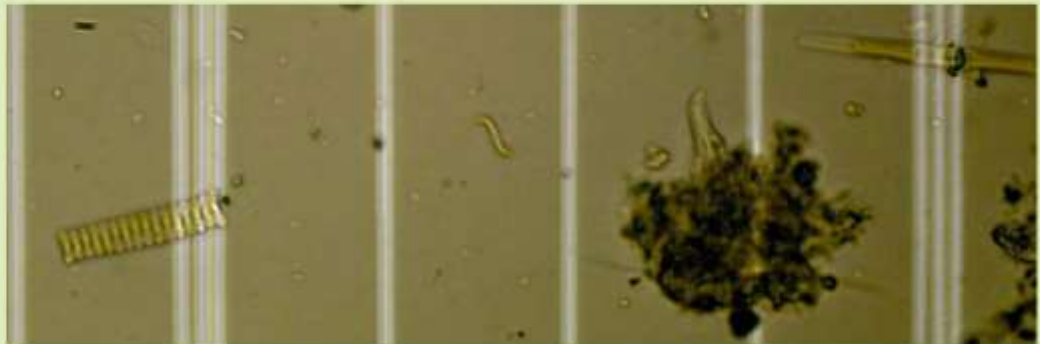
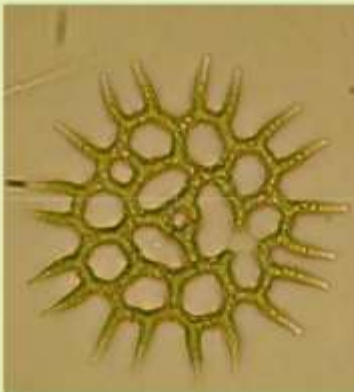
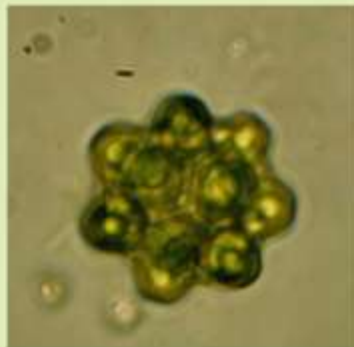
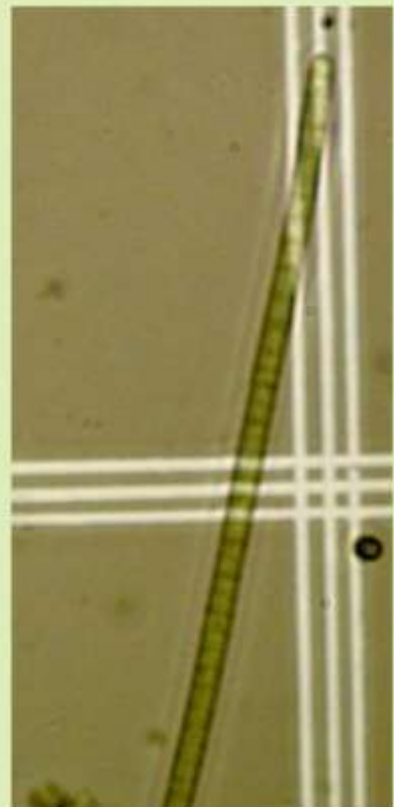
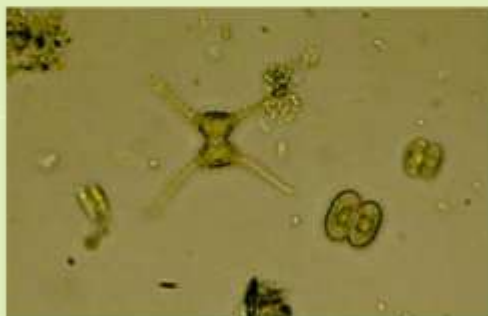
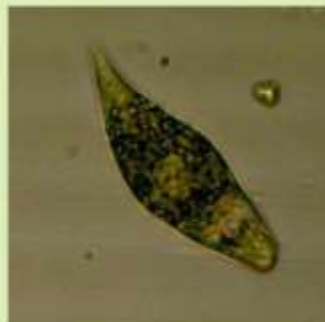
Algae Pictures

Identification	Classification	Description	Density (cells/mL)
<i>Pediastrum</i> sp. (low density)	Chlorophyta- Green algae	Colonial, planktonic	480
<i>Didymocystis</i> sp. (low density)	Chlorophyta- Green algae	Colonial, planktonic	440
<i>Oscillatoria</i> sp. (low density)	Cyanophyta- Blue-green algae	Filamentous, planktonic, potential toxin/ taste and odor producer	320
<i>Coelastrum</i> sp. (low density)	Chlorophyta- Green algae	Colonial, planktonic	280
