Spring Valley Lake Fall 2016 Baseline Data Collection

Prepared for
Spring Valley Lake Association

AquaTechnex,
LLC

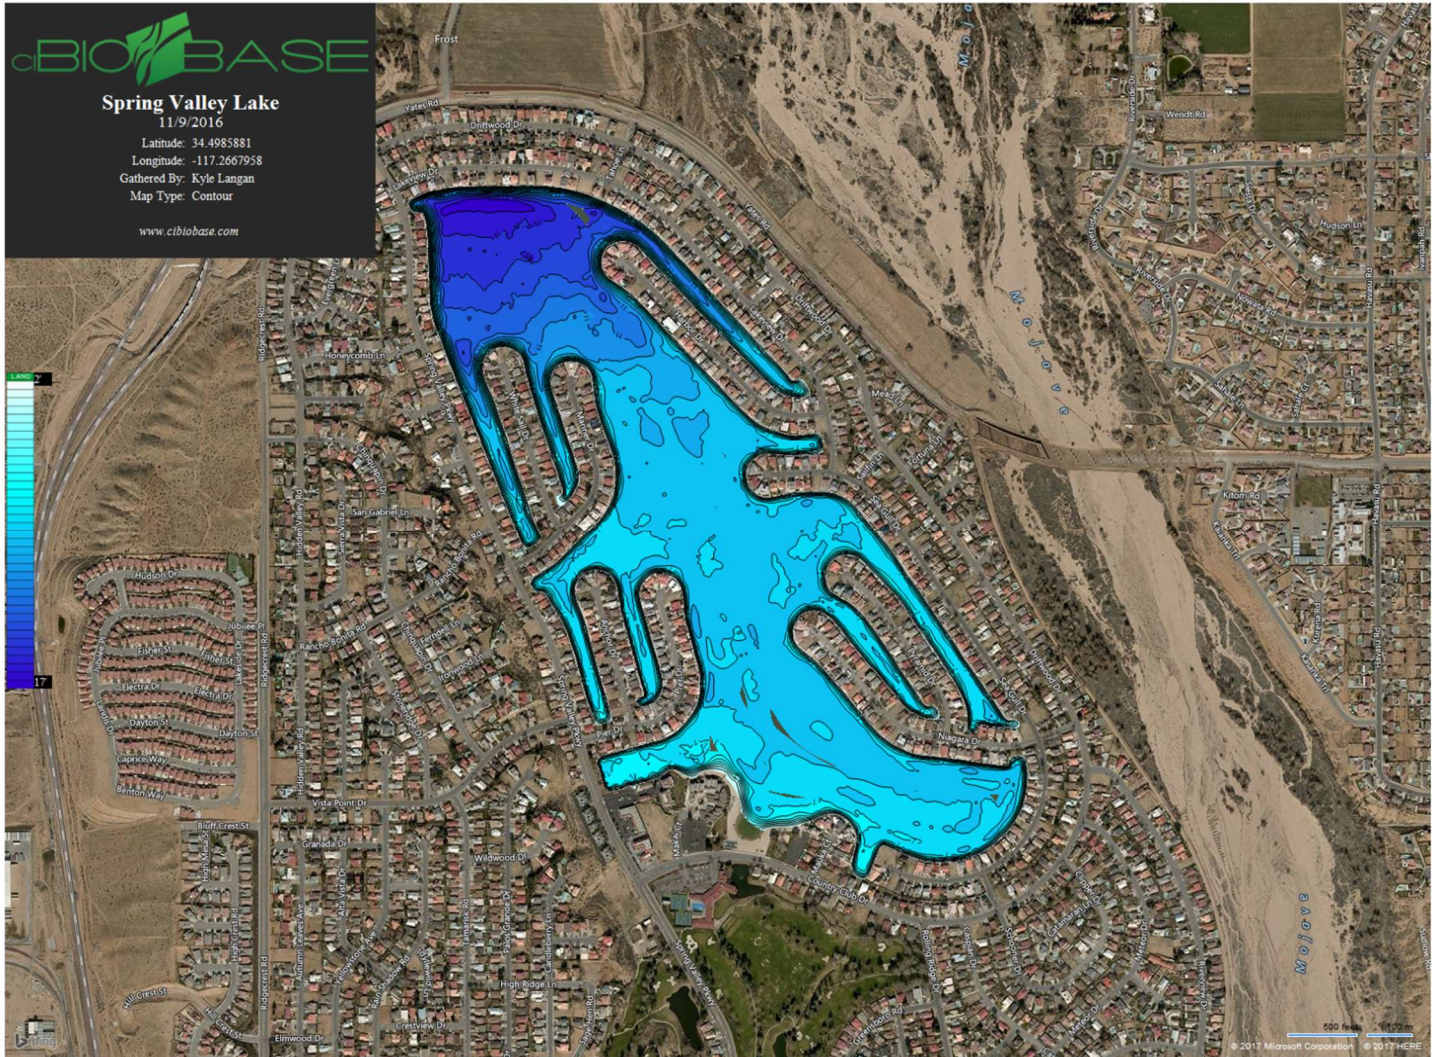
This image shows the current bathymetry of Spring Valley Lake. Almost no change was detected since the previous mapping earlier this spring.

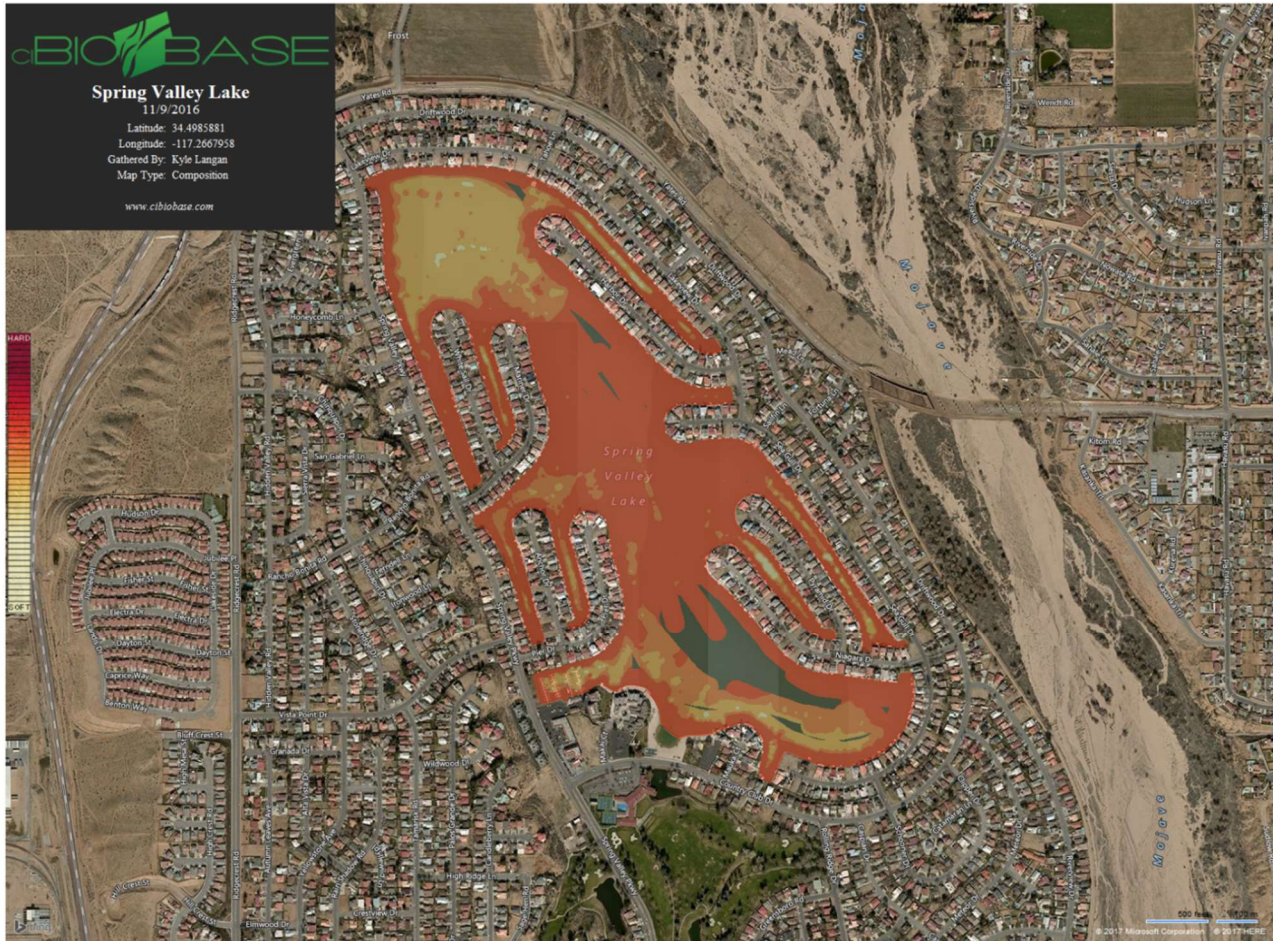
This map shows the current bottom hardness present in the lake. The legend bar on the right shows the graduated scale.

At this point in the Fall of 2016, the aquatic plant coverage in Spring Valley Lake is very low. Most of the Plant growth was detected in the back of the finger between Harbor Drive and Lakeview Drive. There were a few other fingers with very minimal plant growth. The past few years have shown this type of sparse growth pattern. This pattern is not unusual with Spring Valley Lake. Water clarity can limit light penetration into the lake bottom and plants have a hard time establishing.

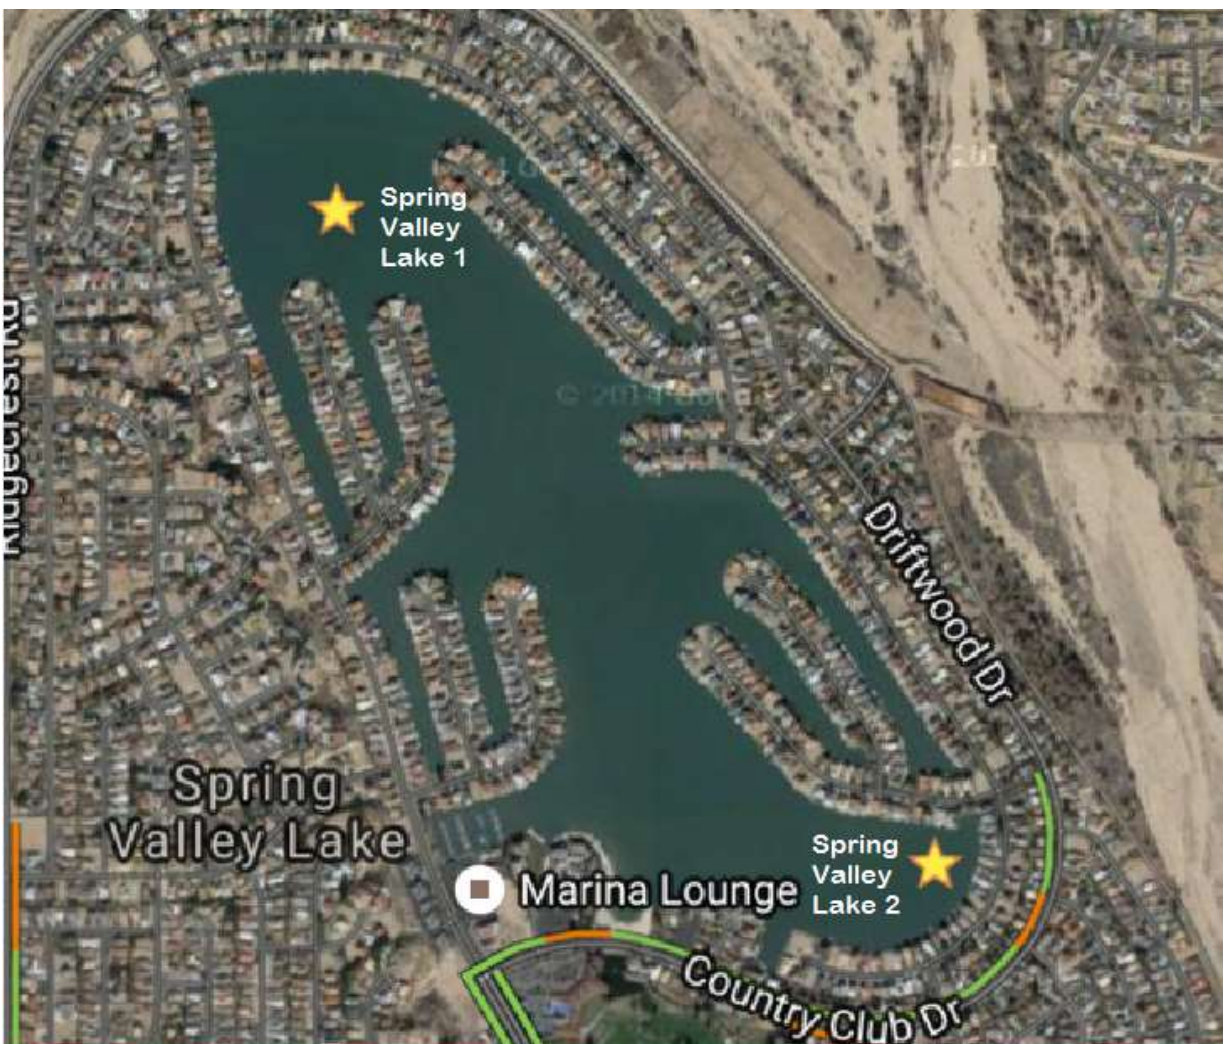
Above: map showing sample locations and sample name

Two water samples were collected around 1PM on 11/9/16. Samples were collected in the North and South portions of the lake indicated on the map below. The samples were analyzed for a variety of water quality data and algae identification. Below is a summarization of the data.
