Lake Town Hall Meeting

July 9, 2018

Spring Valley Lake Association

Aquatic Vegetation and Our Lake

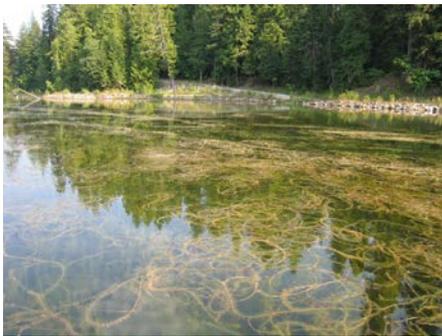
Within another five years, by 1978, our lake was so crammed with milfoil weeds, the Association had to buy lake weed harvesters and operate them 5 days/week, 16 hours per day. The following is what a lake infested with Milfoil weeds looks like.

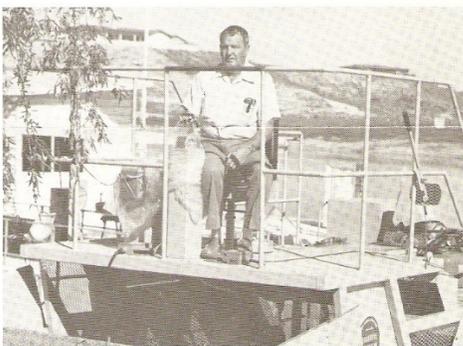
Jim Robertson at console of Weed Harvester

"Our lake weed harvester purchase in April of 1978 has been working 5 days a week, 16 hours a day clearing weeds from the lake."

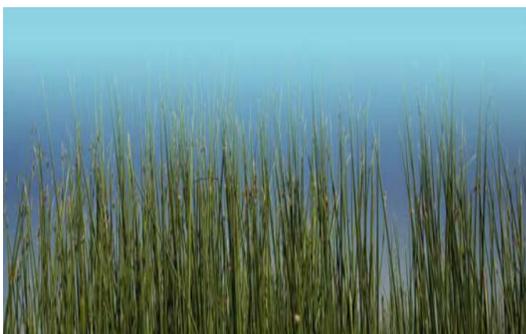
Here is an example of underwater grass (as opposed to weeds):

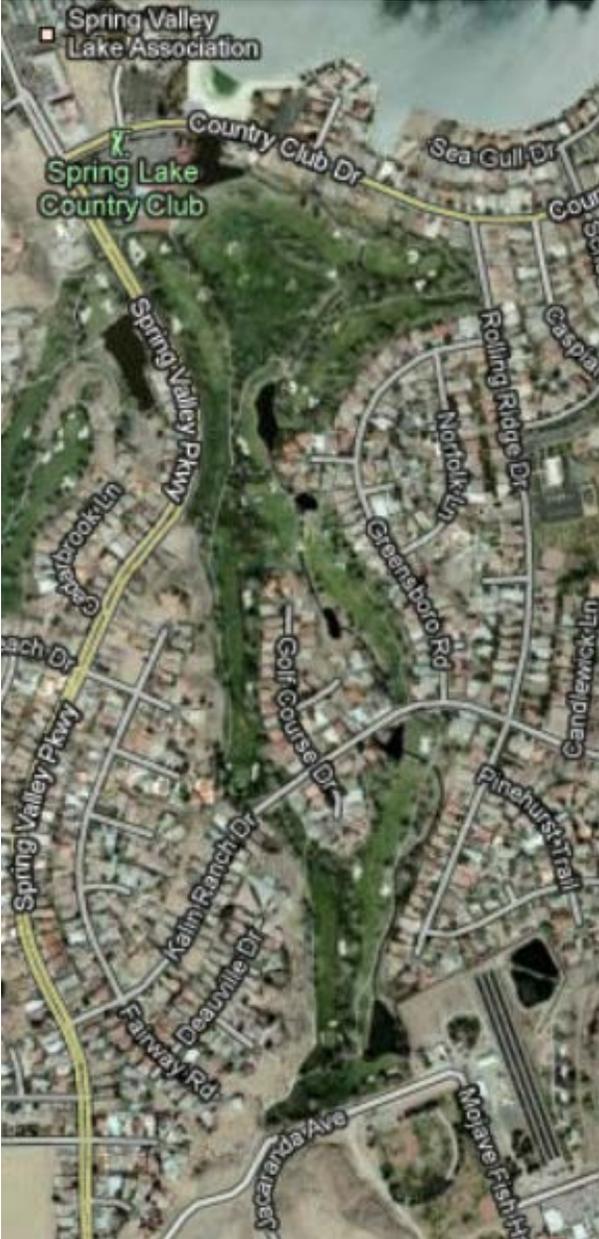
The vast majority of nutrients come to the lake from the Fish Hatchery, via the golf course. Here is a map that shows the route:

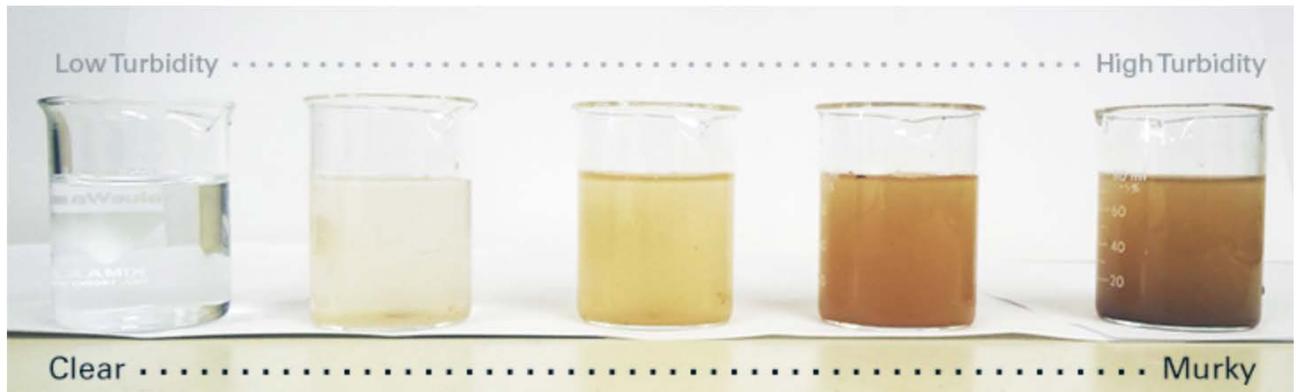
Suspended sediments consist of tiny solids in the water column: silt and clay particles. Here is an illustration of what suspended sediment does to water clarity:

**Smaller amount of
suspended sediments**

**Larger amount
of suspended sediments**

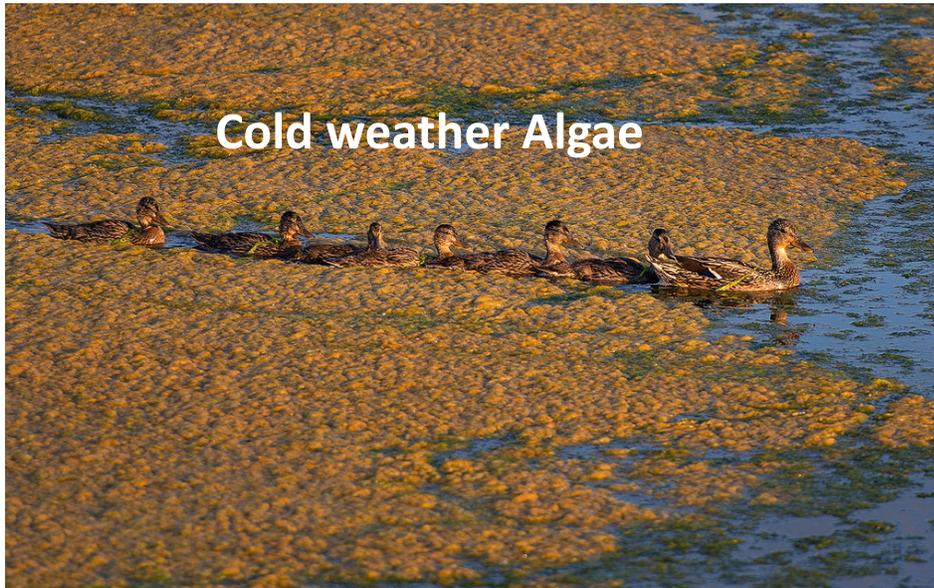
Under 77 degrees is favorable for brown algae; over 77 degrees is favorable for green algae. Here is what it looks like:

Lake Water Temperatures

Effect on algae growth

77 degrees F

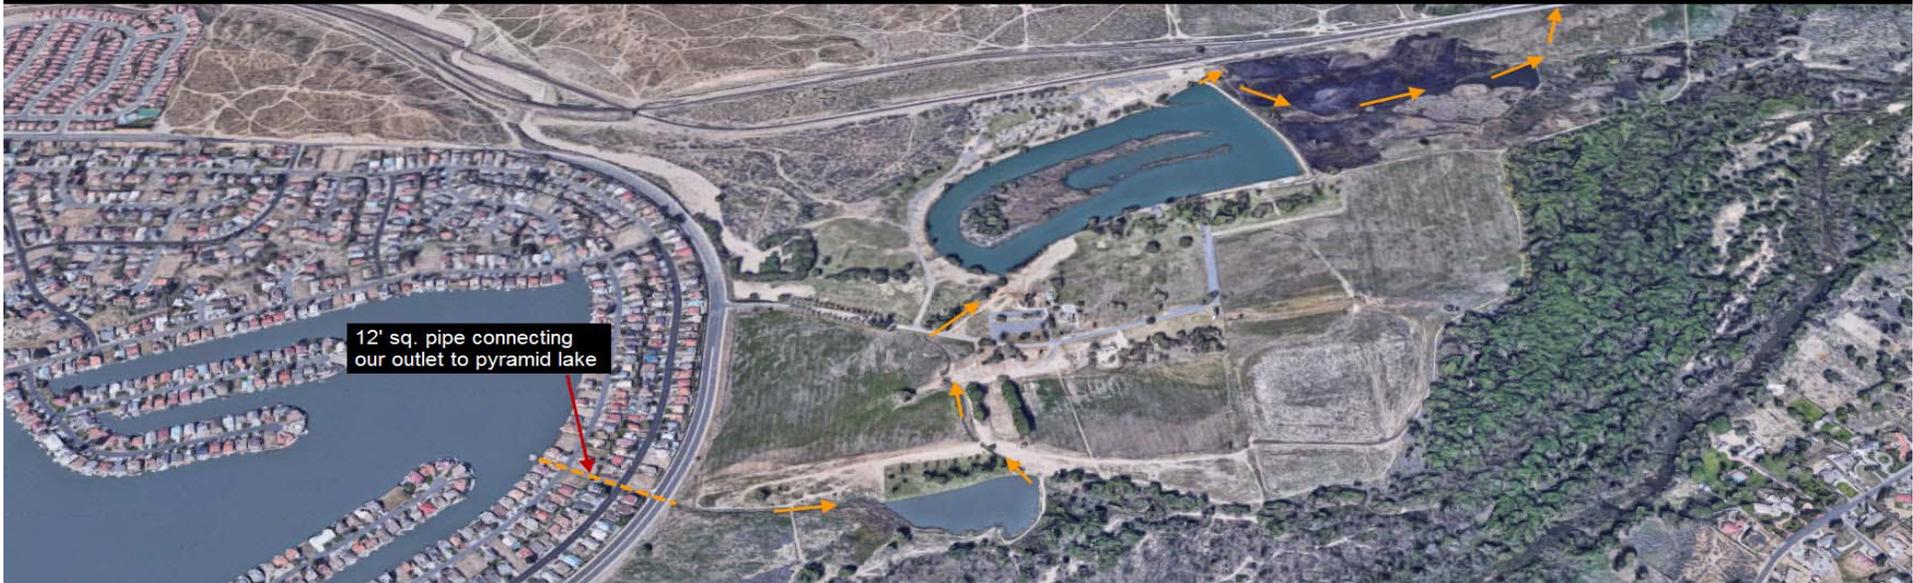
Water Travel From Fish Hatchery

- This water is high in phosphorous.
- Flows from the hatchery through the golf course and into SVL and out to the Mojave wetlands.
- Flows about 1600 gallons per minute = 2.3 mg/d
- SVL saves money on pump costs by receiving hatchery water.
- Two settling ponds at the hatchery were add to help settle out phosphorous and other organic materials.
- The golf course has four ponds which are used to help settle out phosphorous and other organic materials.

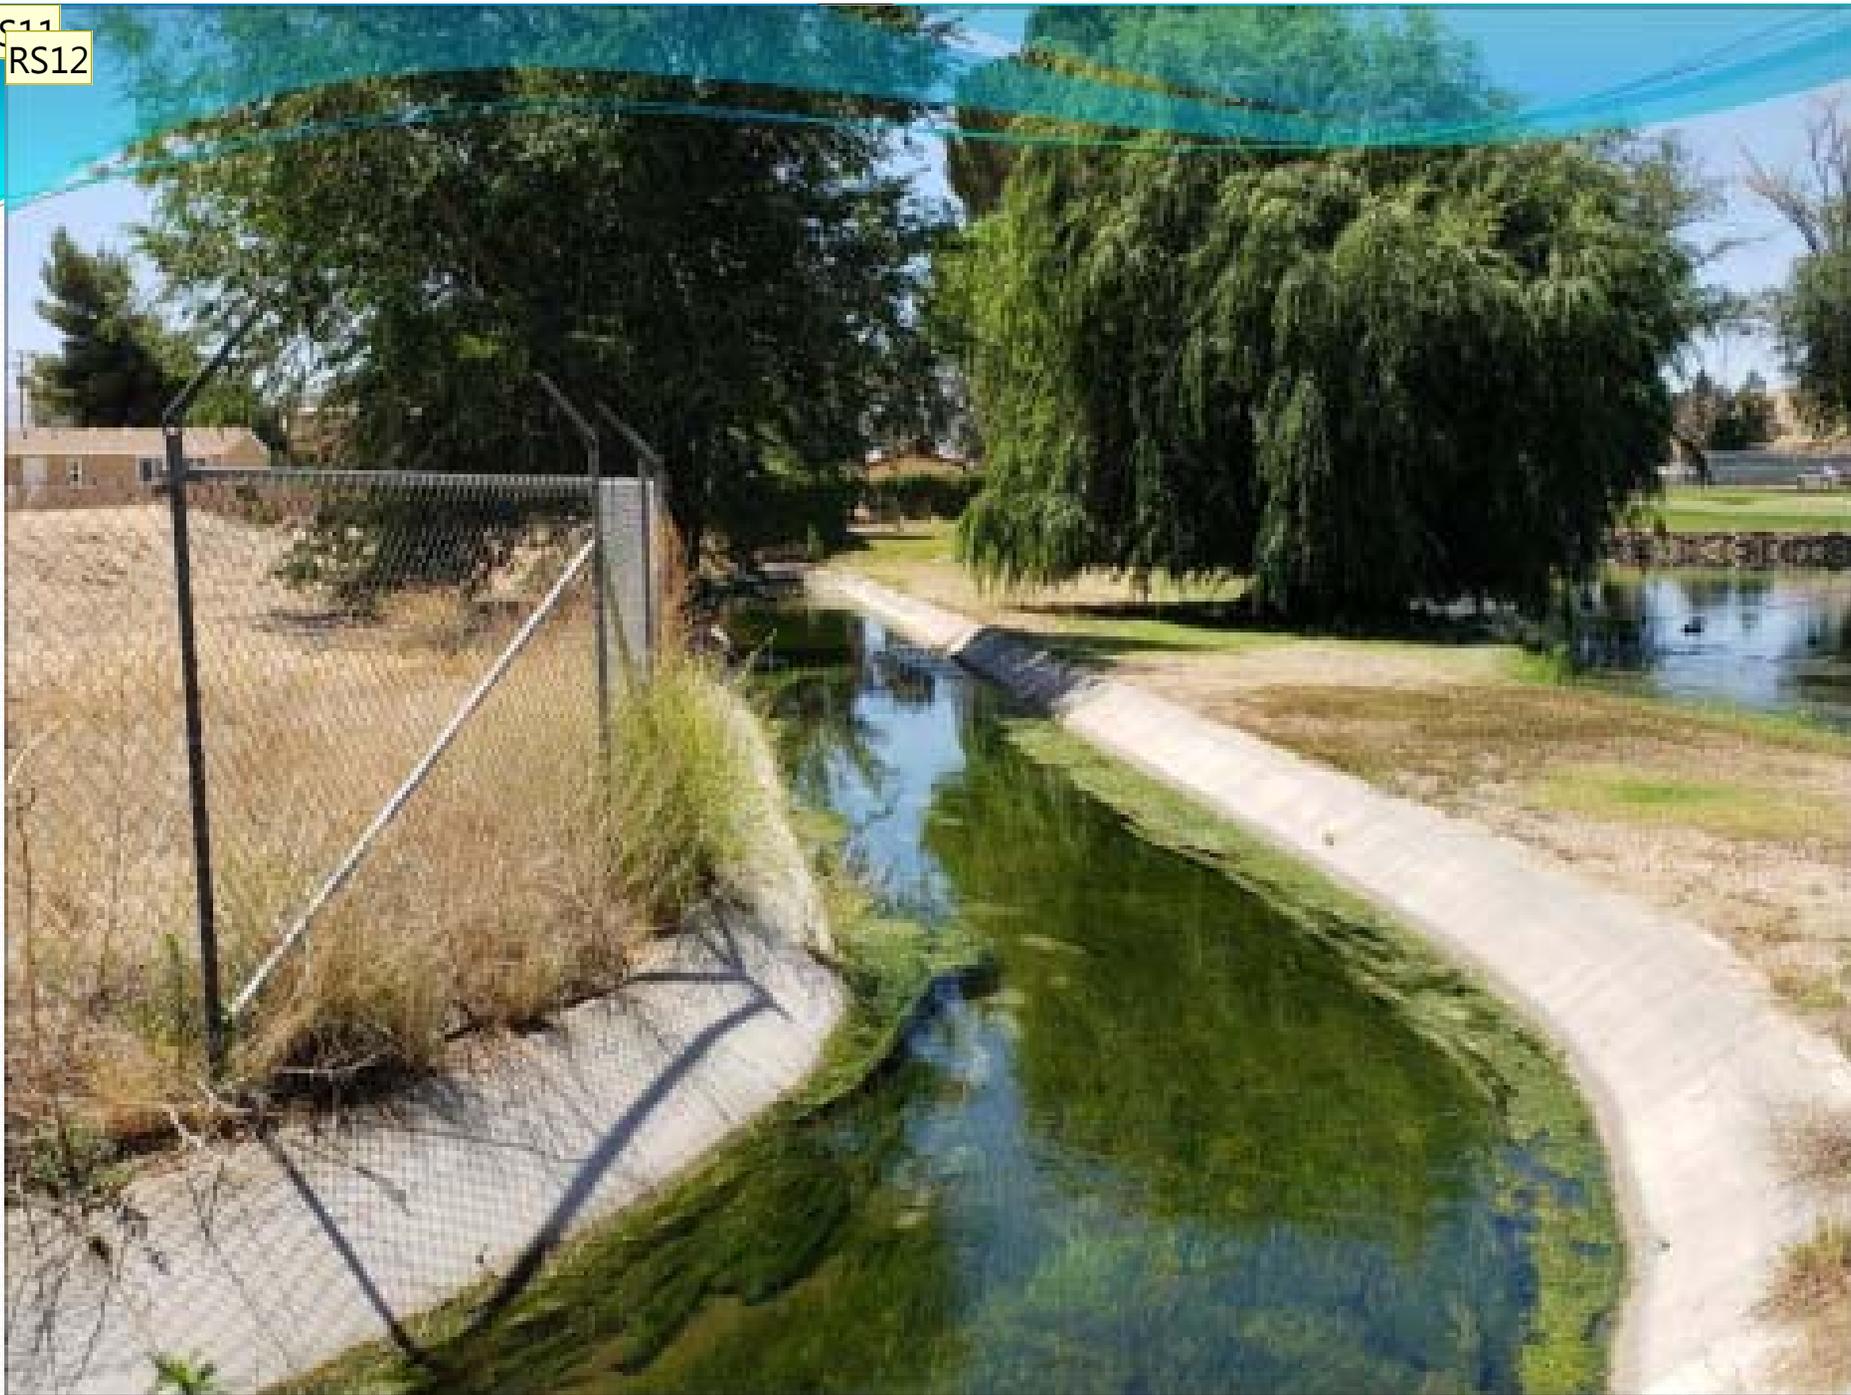
RS11
RS12

- Phosphorus can pollute water and cause excessive algae and plant growth. **Algae Loves Phosphorus**
- Water clarity/turbidity problems result from blooms.
- When algae blooms it could cause orders and will exhaust the supply of phosphorus, they die and start to decompose. During decomposition, dissolved oxygen is removed from the water by micro-organisms that break down the organic material. **The lack of dissolved oxygen makes it difficult for aquatic organisms to survive.**
- Resulting in slow plant growth and fish kills.

- Remove /cut back the amount of phosphorous coming from the hatchery.
- Results =
- Reduced alge blooms in lake
- Improving Water clarity
- Supporting stronger plant growth

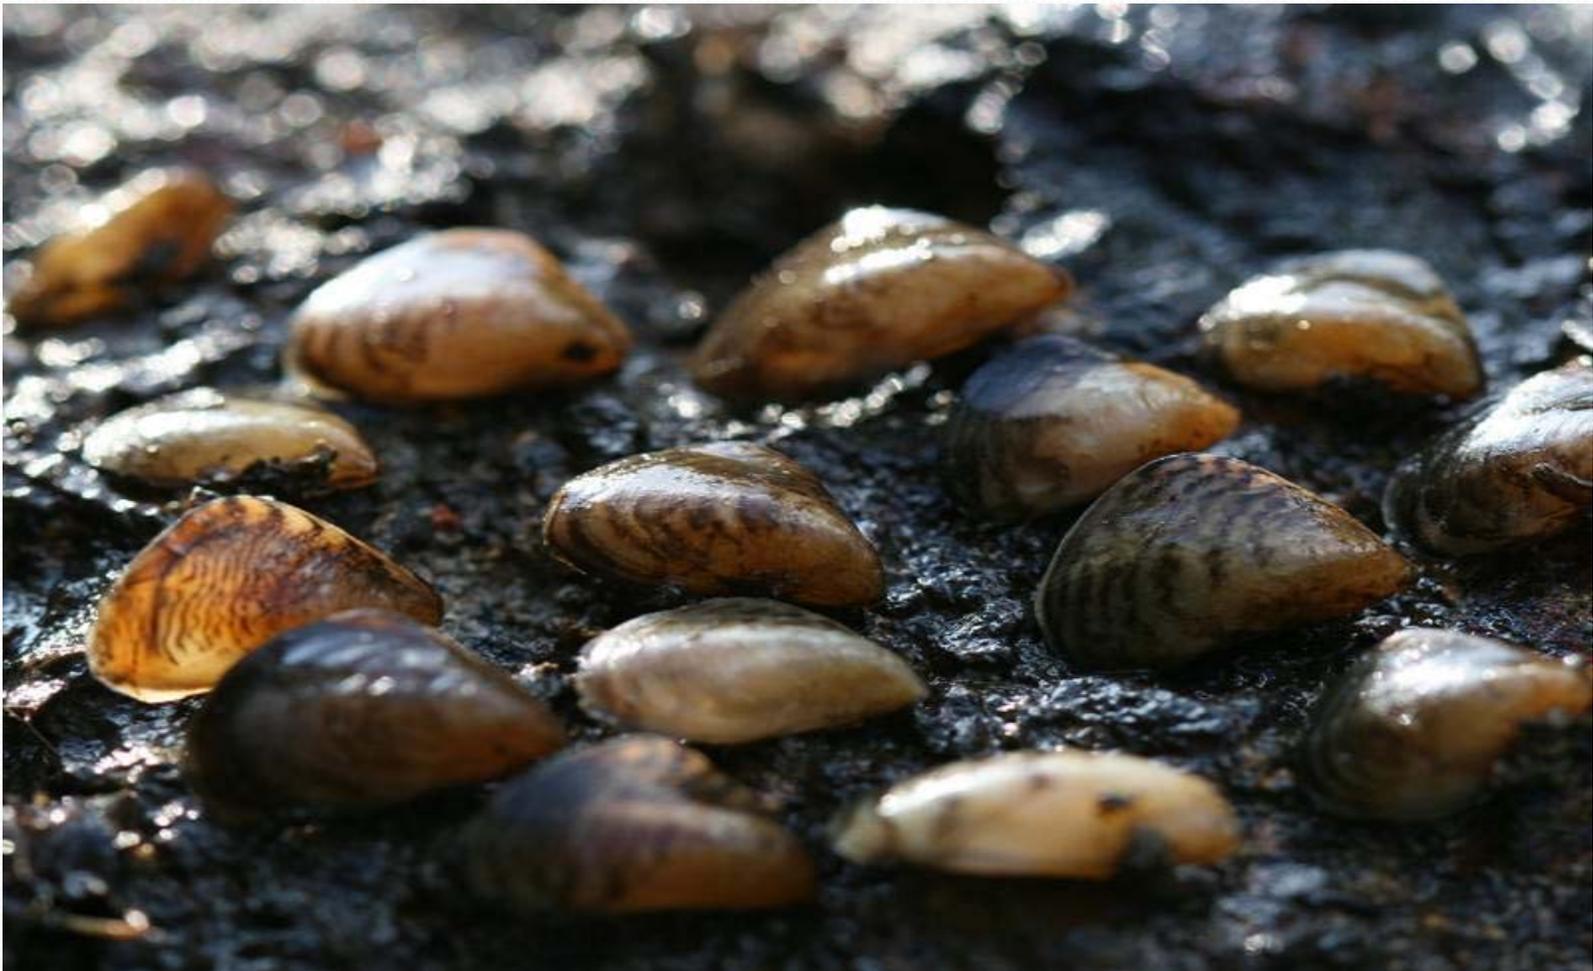
- Ecological **problems** result from **mussel** invasions. Zebra and **quagga mussels** can kill native freshwater **mussels**, these invasive species can outcompete native **mussels** and other filter feeding invertebrates for food
- They are invasive producing 1000 eggs a day
- They eat the same food as fish and reducing food chain supply.
- They live up to four years
- Quagga mussel can filter 2 liters of water in 24hrs
- Out of water they take 14 days to die
- Huge Maintenance costs to remove.

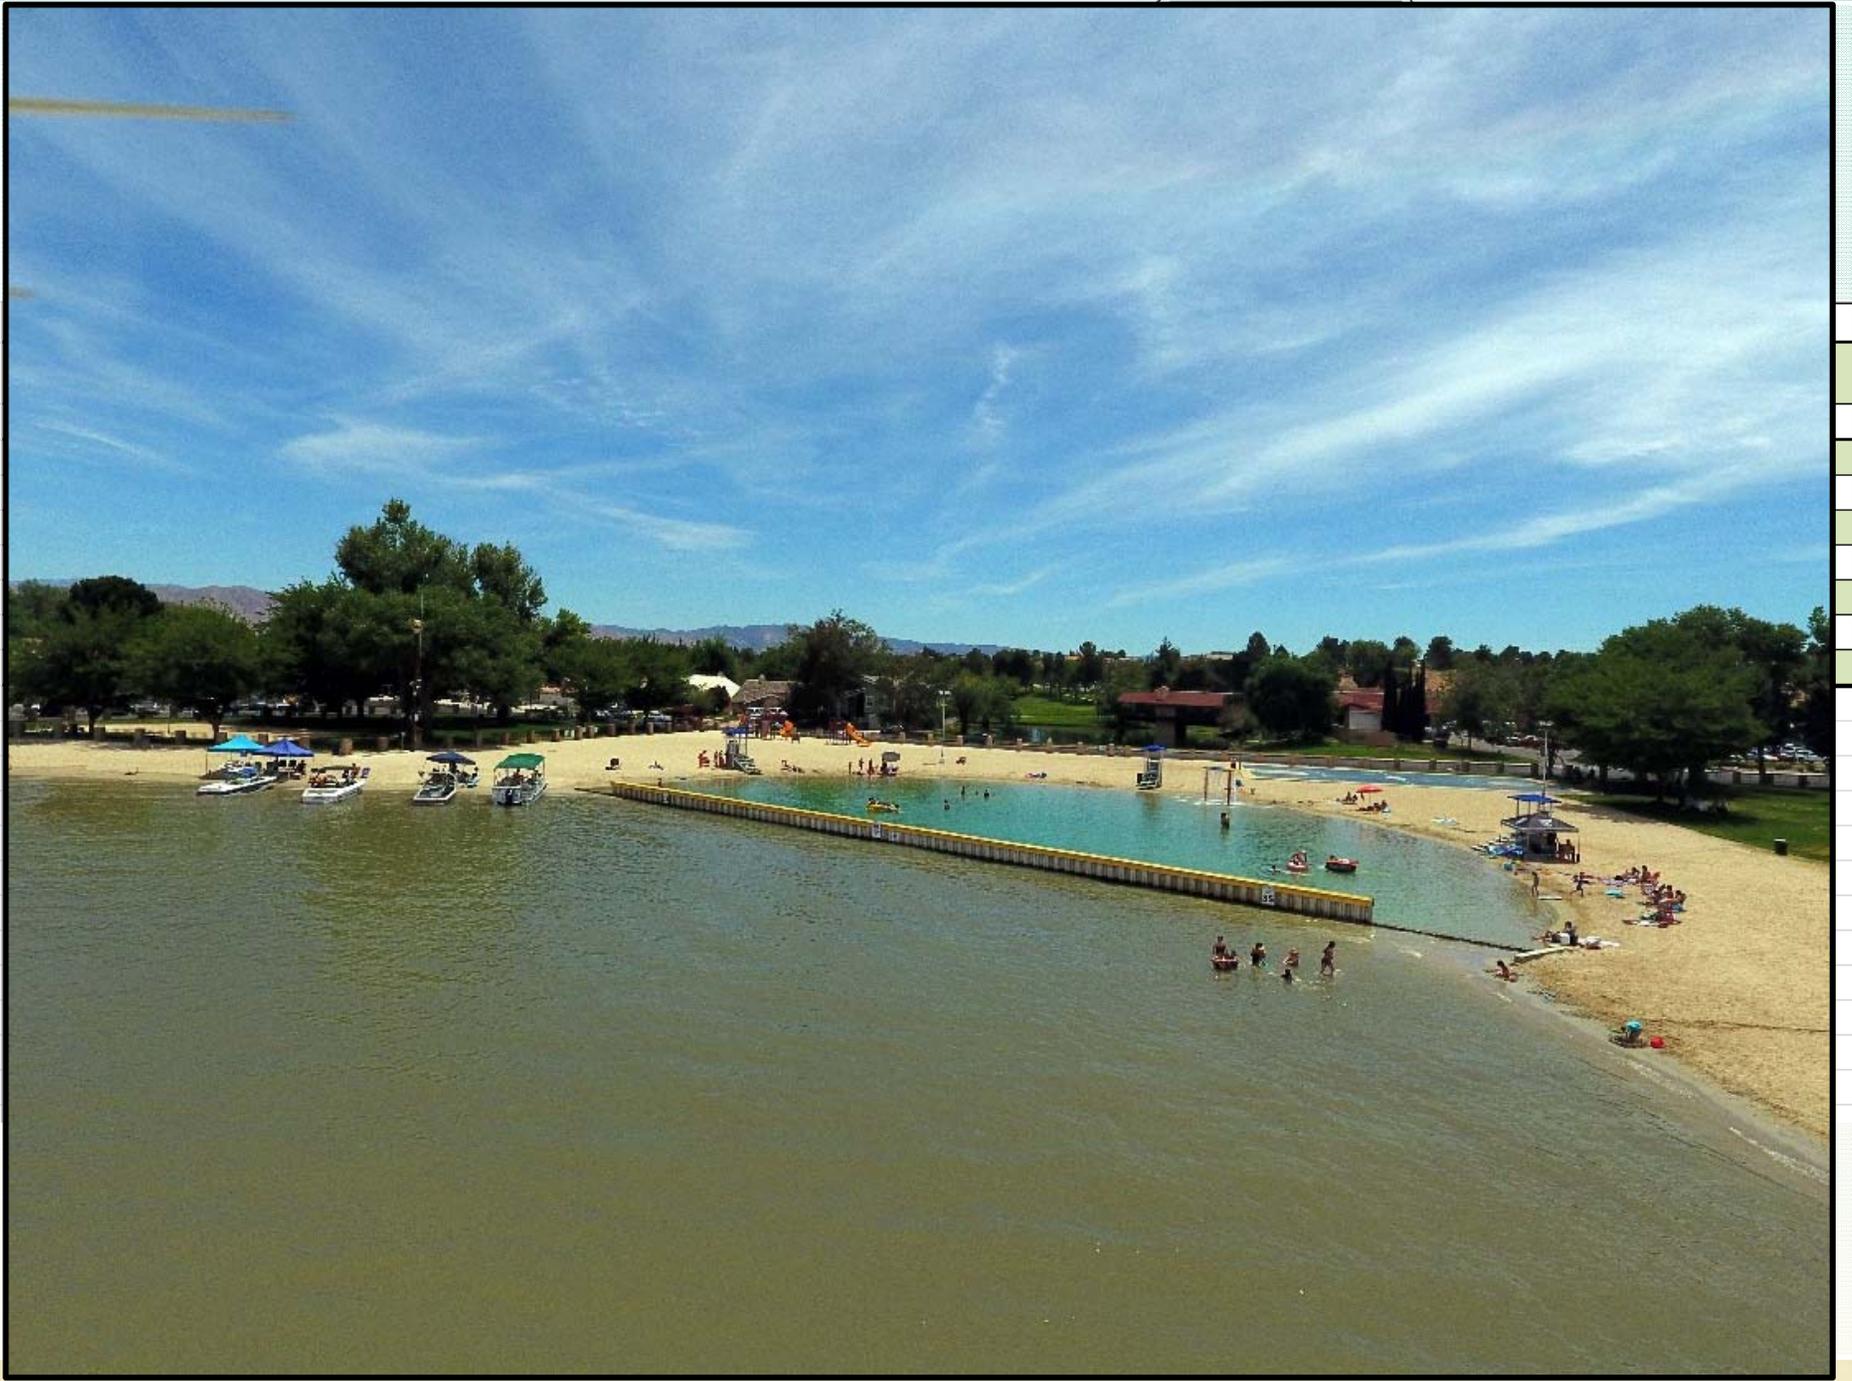
2018							
Nutrient Level average			Algae Test Results average				
Date	Nitrate	Phosphorous	Date	Identification	Classification	Description	Density (cells/mL)
Before Alum 3/18	.39mg/L	.016mg/L	SVL Lake 5/18	Eunotia sp.	Bacillariophyta-Diatoms	Single-celled, planktonic	176,250
After Alum 4/26	ND	.0071mg/L	SVL Lake 6/18	Eunotia sp.	Bacillariophyta-Diatoms	Single-celled, planktonic	289,050
After Alum 5/11	<.02mg/L	.0025mg/L	SVL Lake 6/18	Eunotia sp.	Bacillariophyta-Diatoms	Single-celled, planktonic	252,250
SVL Lake 6/13	<.02mg/L	.0029mg/L					
SVL Lake 6/25	<.02mg/L	.0017mg/L
